HEADEND

Volume 32, Number 2

March–April 2018

SHOP REPORT

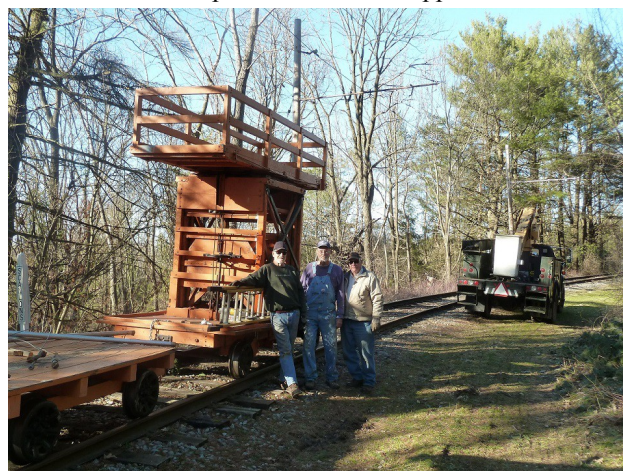
Line car 020 has been in use making overhead repairs. Here, from left to right, are Taylor Reed, Rick Holahan and Bob Achilles after an arduous day. In the background is one of the bracket arms just installed by the crew but before the contact wire was attached. In the background is the RGV bucket truck, generously made available to expedite repairs. *Photo by C. Lowe.*

Work resumed the next day when Bob Achilles, Rick Holahan, Charlie Lowe and Taylor Reed used the RGV bucket truck to install replacement bracket arms at poles 48 and 49. These were selected for length so that the upper cables could be reused without modification. This

same crew re-assembled on Tuesday, April 24 and installed new double-insulated lower cables and attached the contact wire to the new bracket arms. In addition, Dick Holbert inspected and tested five of the line's eight lightning arresters and found each to be in good condition.

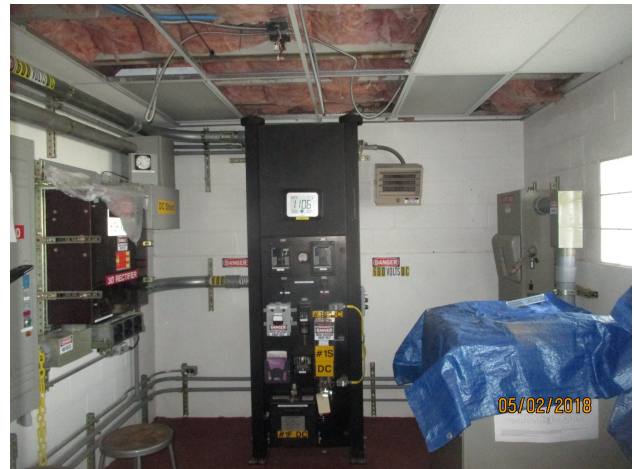
With roof leakage finally entering the substation, it became necessary at the end of the 2017 season to shut down the substation. Leakage had ruined two ceiling-mounted sensors, and dampness was discovered on substation walls. Ceiling panels were distorted and wet, the fiberglass insulation was ruined, and small animals were found to have entered the substation.

Here is a view looking inward from the door toward the inside of the NYMT substation. The large electrical panel in the center of the photograph was obtained during NYMT's earliest days and was formerly a part of a Denver trolleybus installation. *Photo by C. Lowe.*

The substation ceiling repair plan is to remove the old ceiling materials and replace them with a new corrugated fiberglass ceiling on a slight slope toward the far wall, visible in the above photograph. A slight downward slope will direct any drips toward a gutter mounted on the far wall, guiding the water through a series of piping to the outside. Kindorf beams will support the corrugated fiberglass and a 1-inch-thick layer of insulating material which will help keep the substation warm throughout cold winter months.

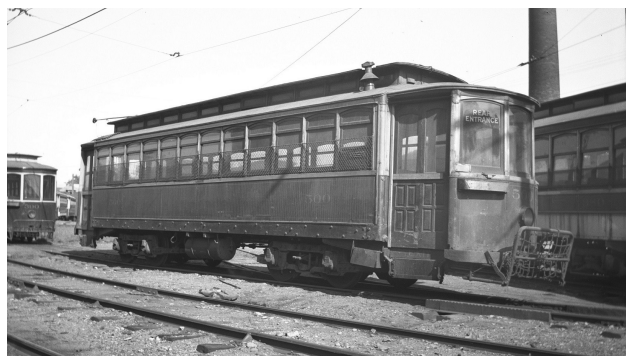
N.Y.S. Railways, Rochester Lines 500 Photo by George Slyford

In the last issue of *Headend*, we studied the double-truck double-end Brill-built low-500s (cars 500–509). These cars were part of a massive 1903–1907 replacement of Rochester Railway Company’s aging and outdated fleet of single-truck cars. Some 203 new double-truck passenger cars were placed in service during these years.

As built, the low 500s were double-end cars. This was in keeping with the lack of loops on the Rochester Railway system. During the 1910s and early 1920s, nearly all lines in Rochester were equipped with turning loops to improve streetcar service. Single-end cars, with controls in just one end of the car, weighed less than comparable

During 1917, 1918 and 1919, New York State Railways rebuilt at least 102 of Rochester’s double-end cars into single-end cars. A new paint scheme of green and cream replaced the old yellow of Rochester Railway days. As for the 500–509 cars, only one was single-ended. This was done in 1917 while the remainder of the cars were rebuilt, but remained double-ended, in 1917–1920. Why car 500 was the only one of the series to be single-ended has been lost to the “infinite corridors of time.” Our 1936 photo shows the front door blocked shut forever and the rear pole hooked down for a last time but does not show, conspicuously, any trace of a hook for a front pole.
